## PROJECT INTRODUCTION AND WAIVER ELIGIBILITY

0 25 50 100 Feet</div>	<b>FIGURE 2: SITE C2</b> <b>ST JOHN: US VIRGIN ISLANDS</b> <b>ROADWAY REPAIRS</b>  MARCH, 2021
--	--	---	--

FIGURE 3: SITE C3  
ST JOHN: US VIRGIN ISLANDS  
ROADWAY REPAIRS

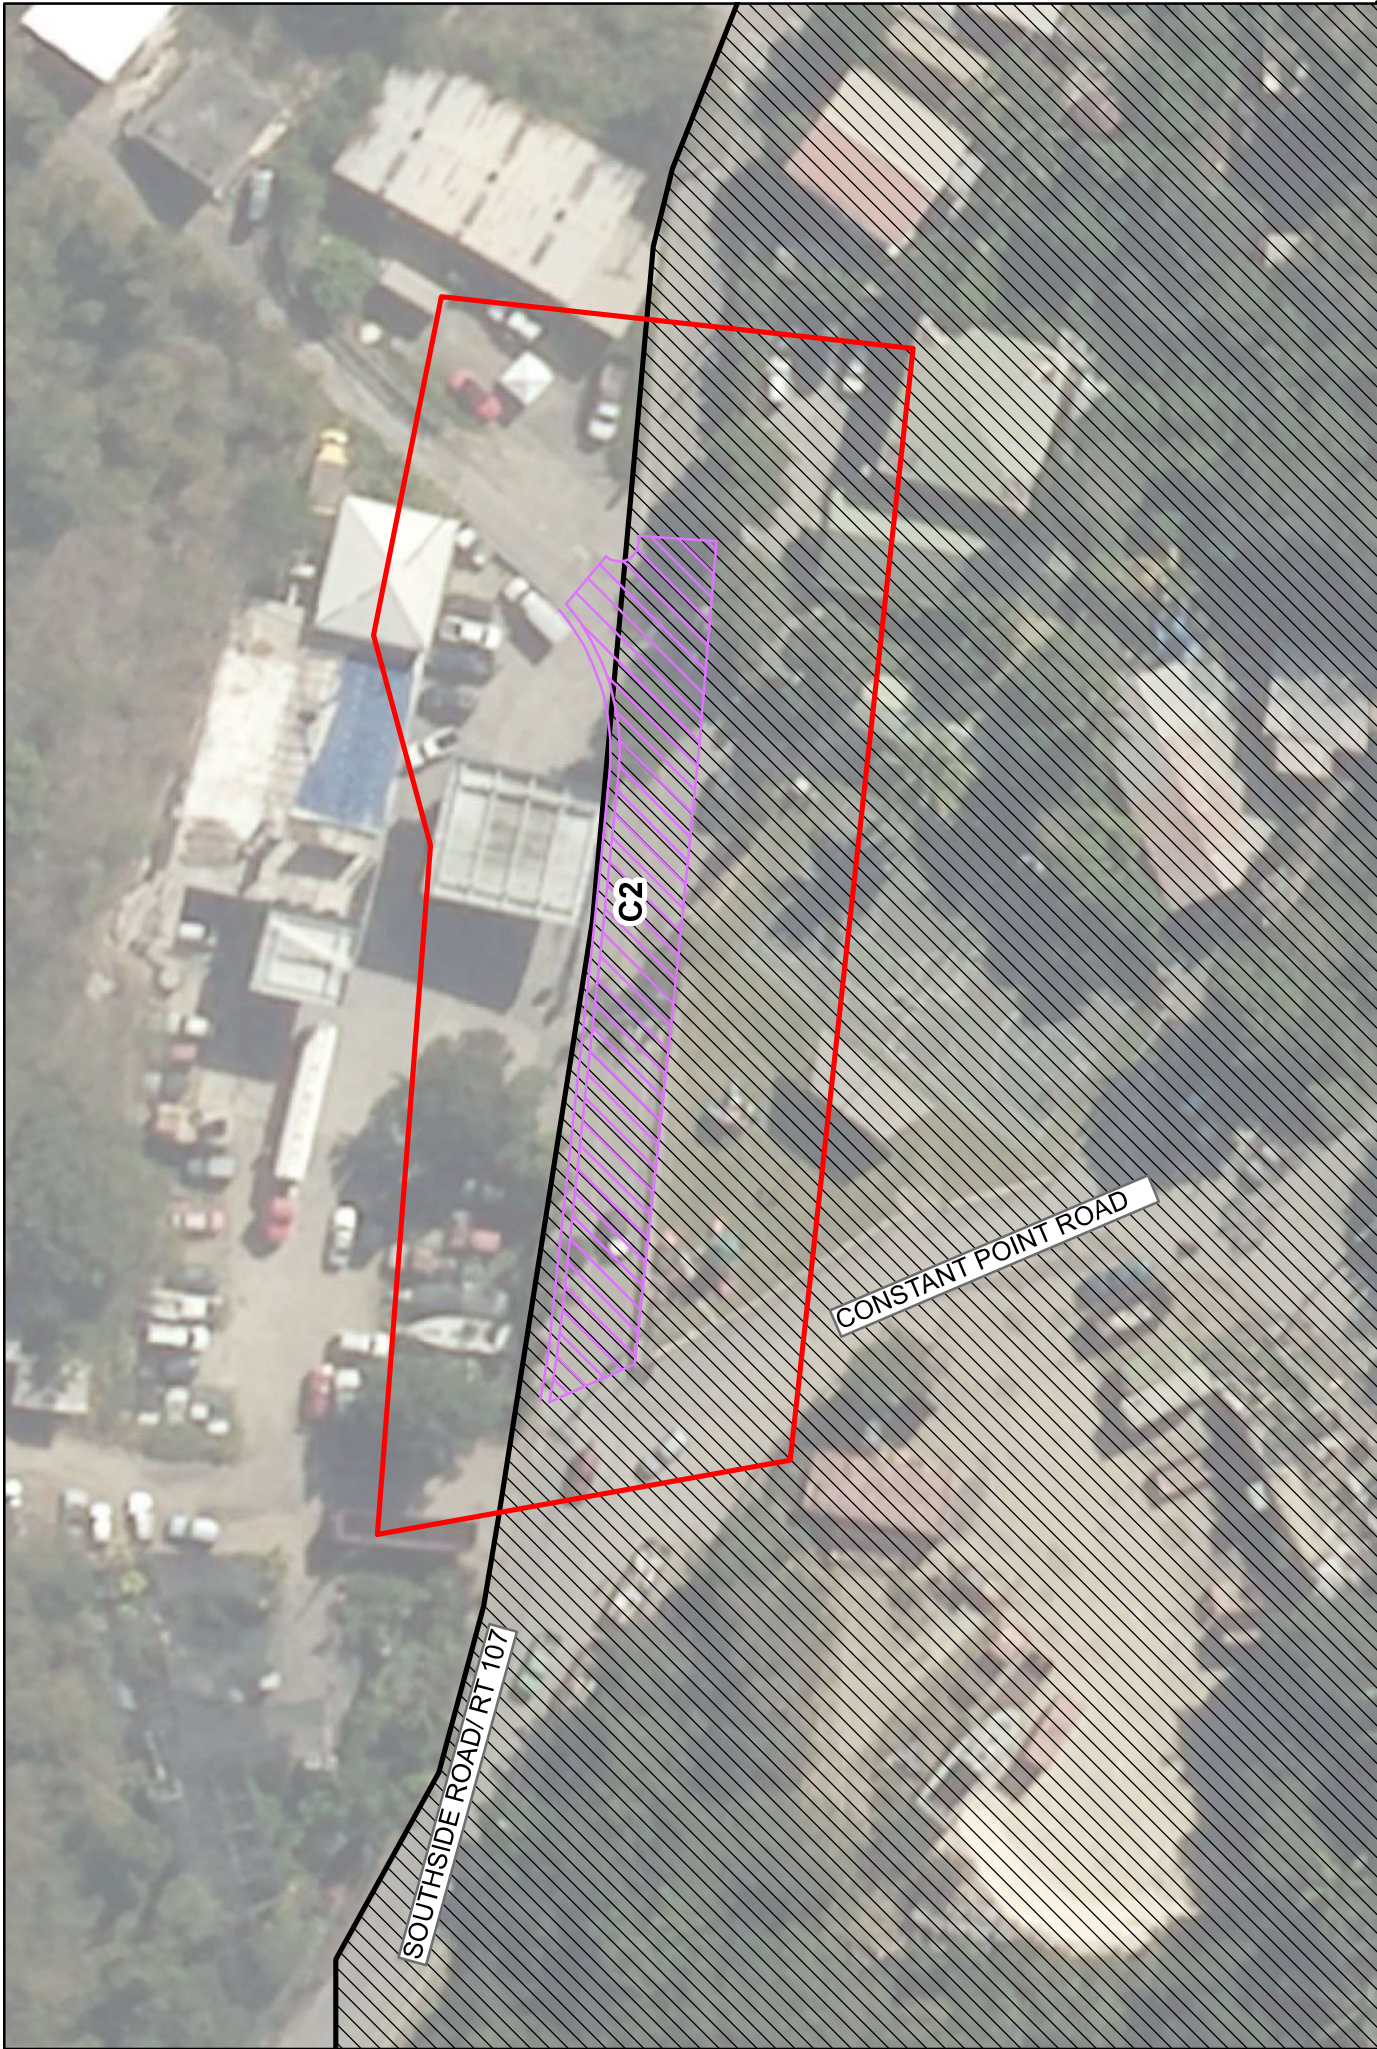
Site C2 (Figure 2) was impacted by extreme stormwater runoff and includes damage to asphalt, stormwater swales and guts. A detailed damage description is included in Appendix B and detailed conceptual design plans can be found in Appendix C. Proposed work at this site includes milling and repaving with 3" depth asphalt; installation of a new concrete swale; and new pavement markings and cleaning of the gut at the end of the road. No utility relocation is deemed necessary at this site.

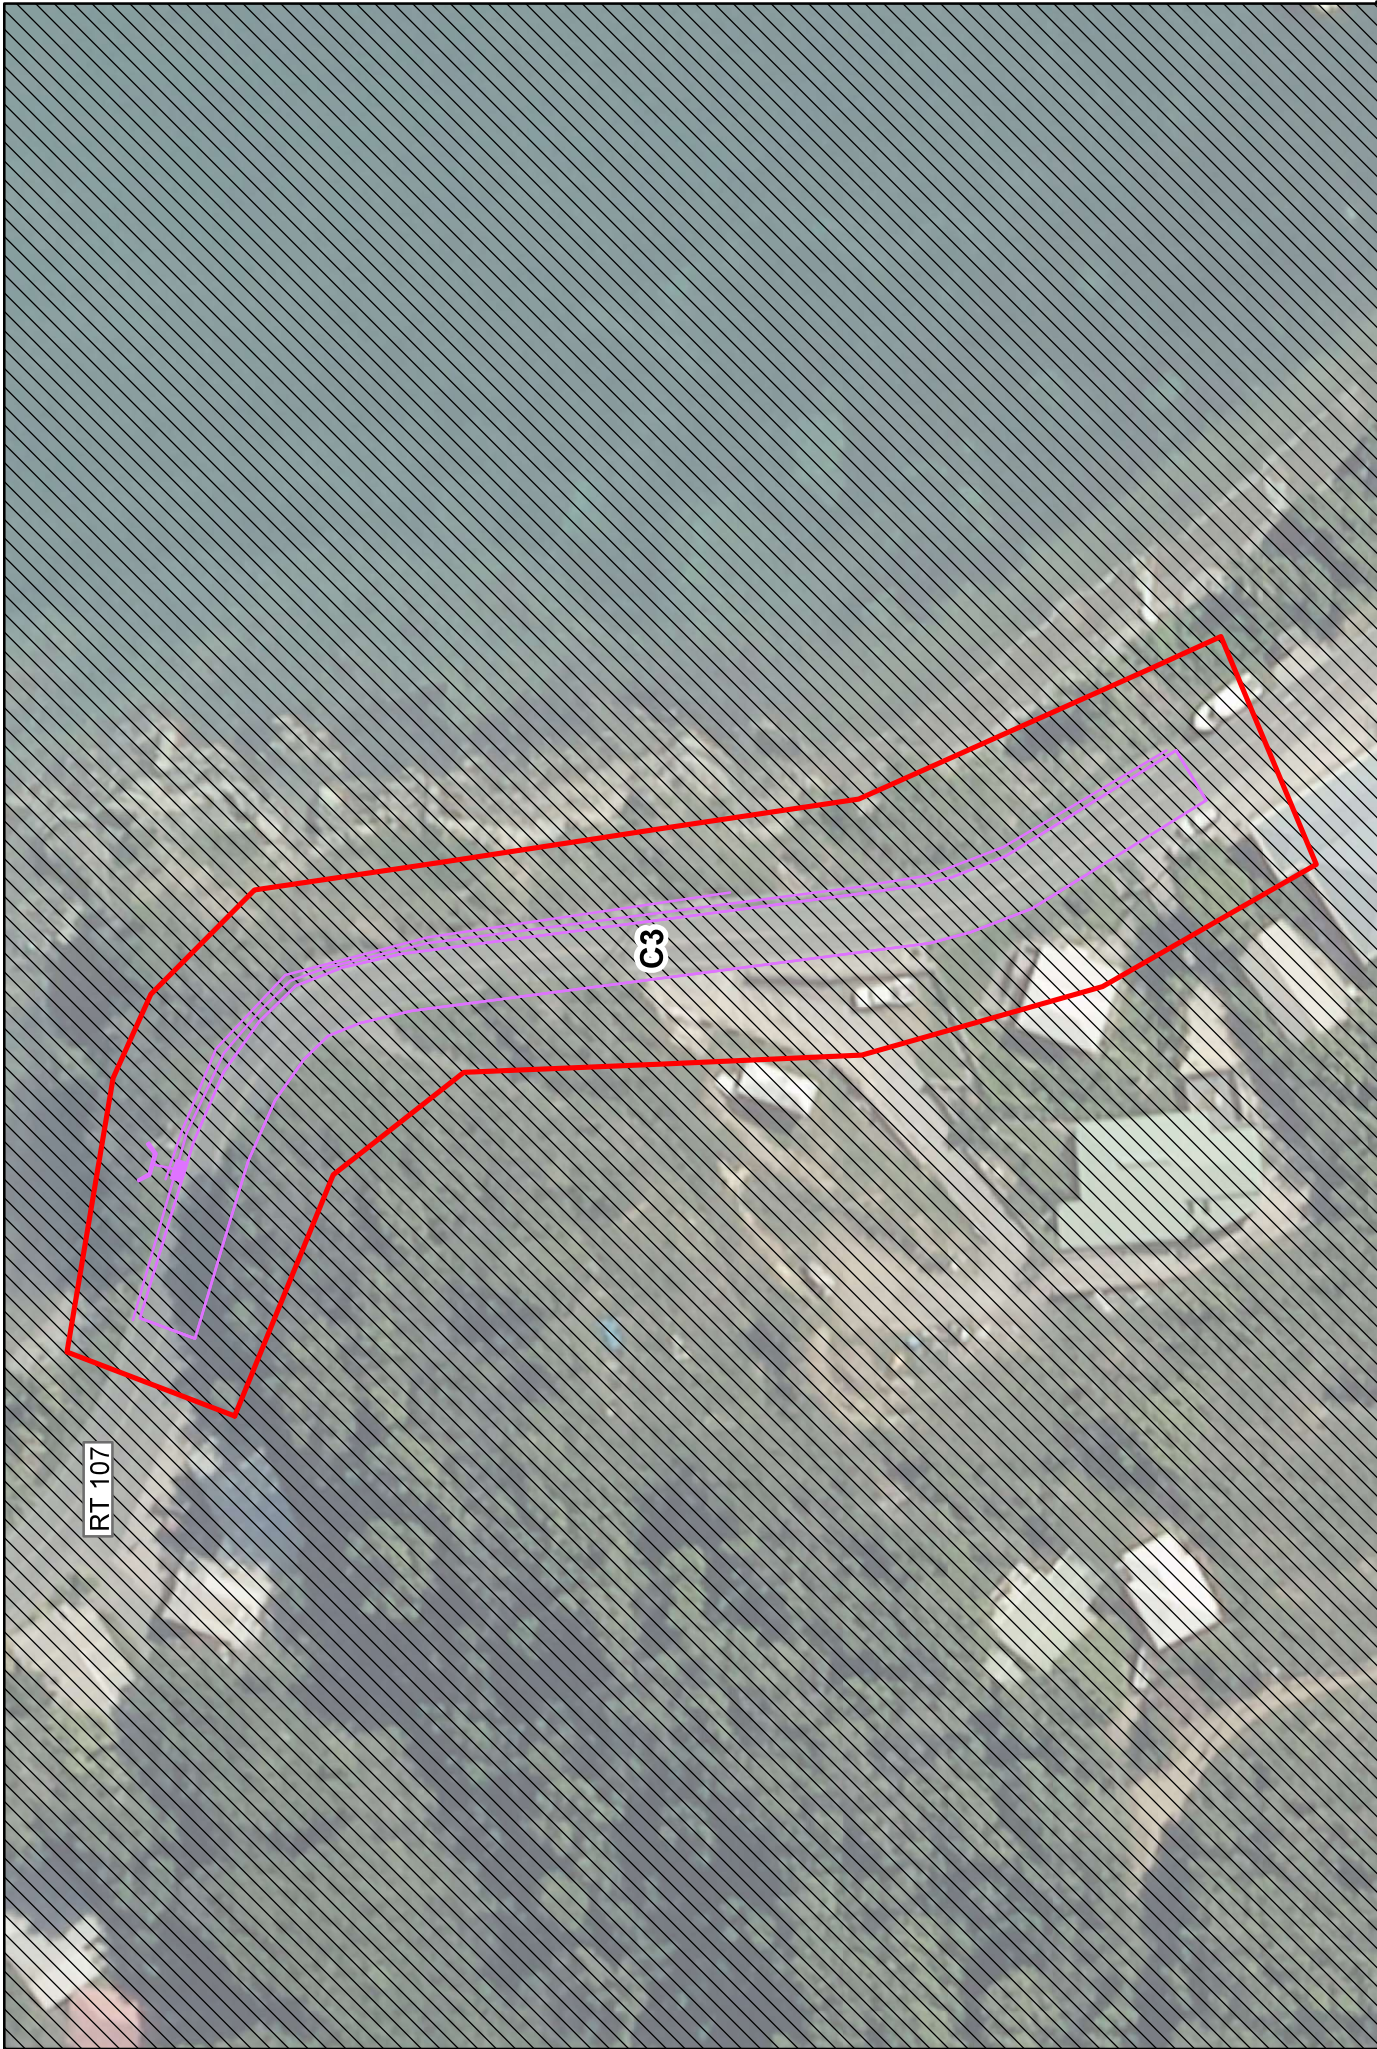
Site C3 (Figure 3) was impacted by roadway embankment damage, shoulder washout, and guardrail damage due to high water from the ocean during hurricane Irma. A detailed damage description is included in Appendix B and detailed conceptual design plans can be found in Appendix C. Proposed work includes temporary shoring and bracing; reconstruction of approximately 460 feet of concrete road; construction of a new 240 feet long by 15 feet high cantilevered retaining wall; removal and replacement of the catch basin at the trench drain; flowable fill under concrete pavement adjacent to trench drain; and removal and replacement of the guard rail and utility relocations.

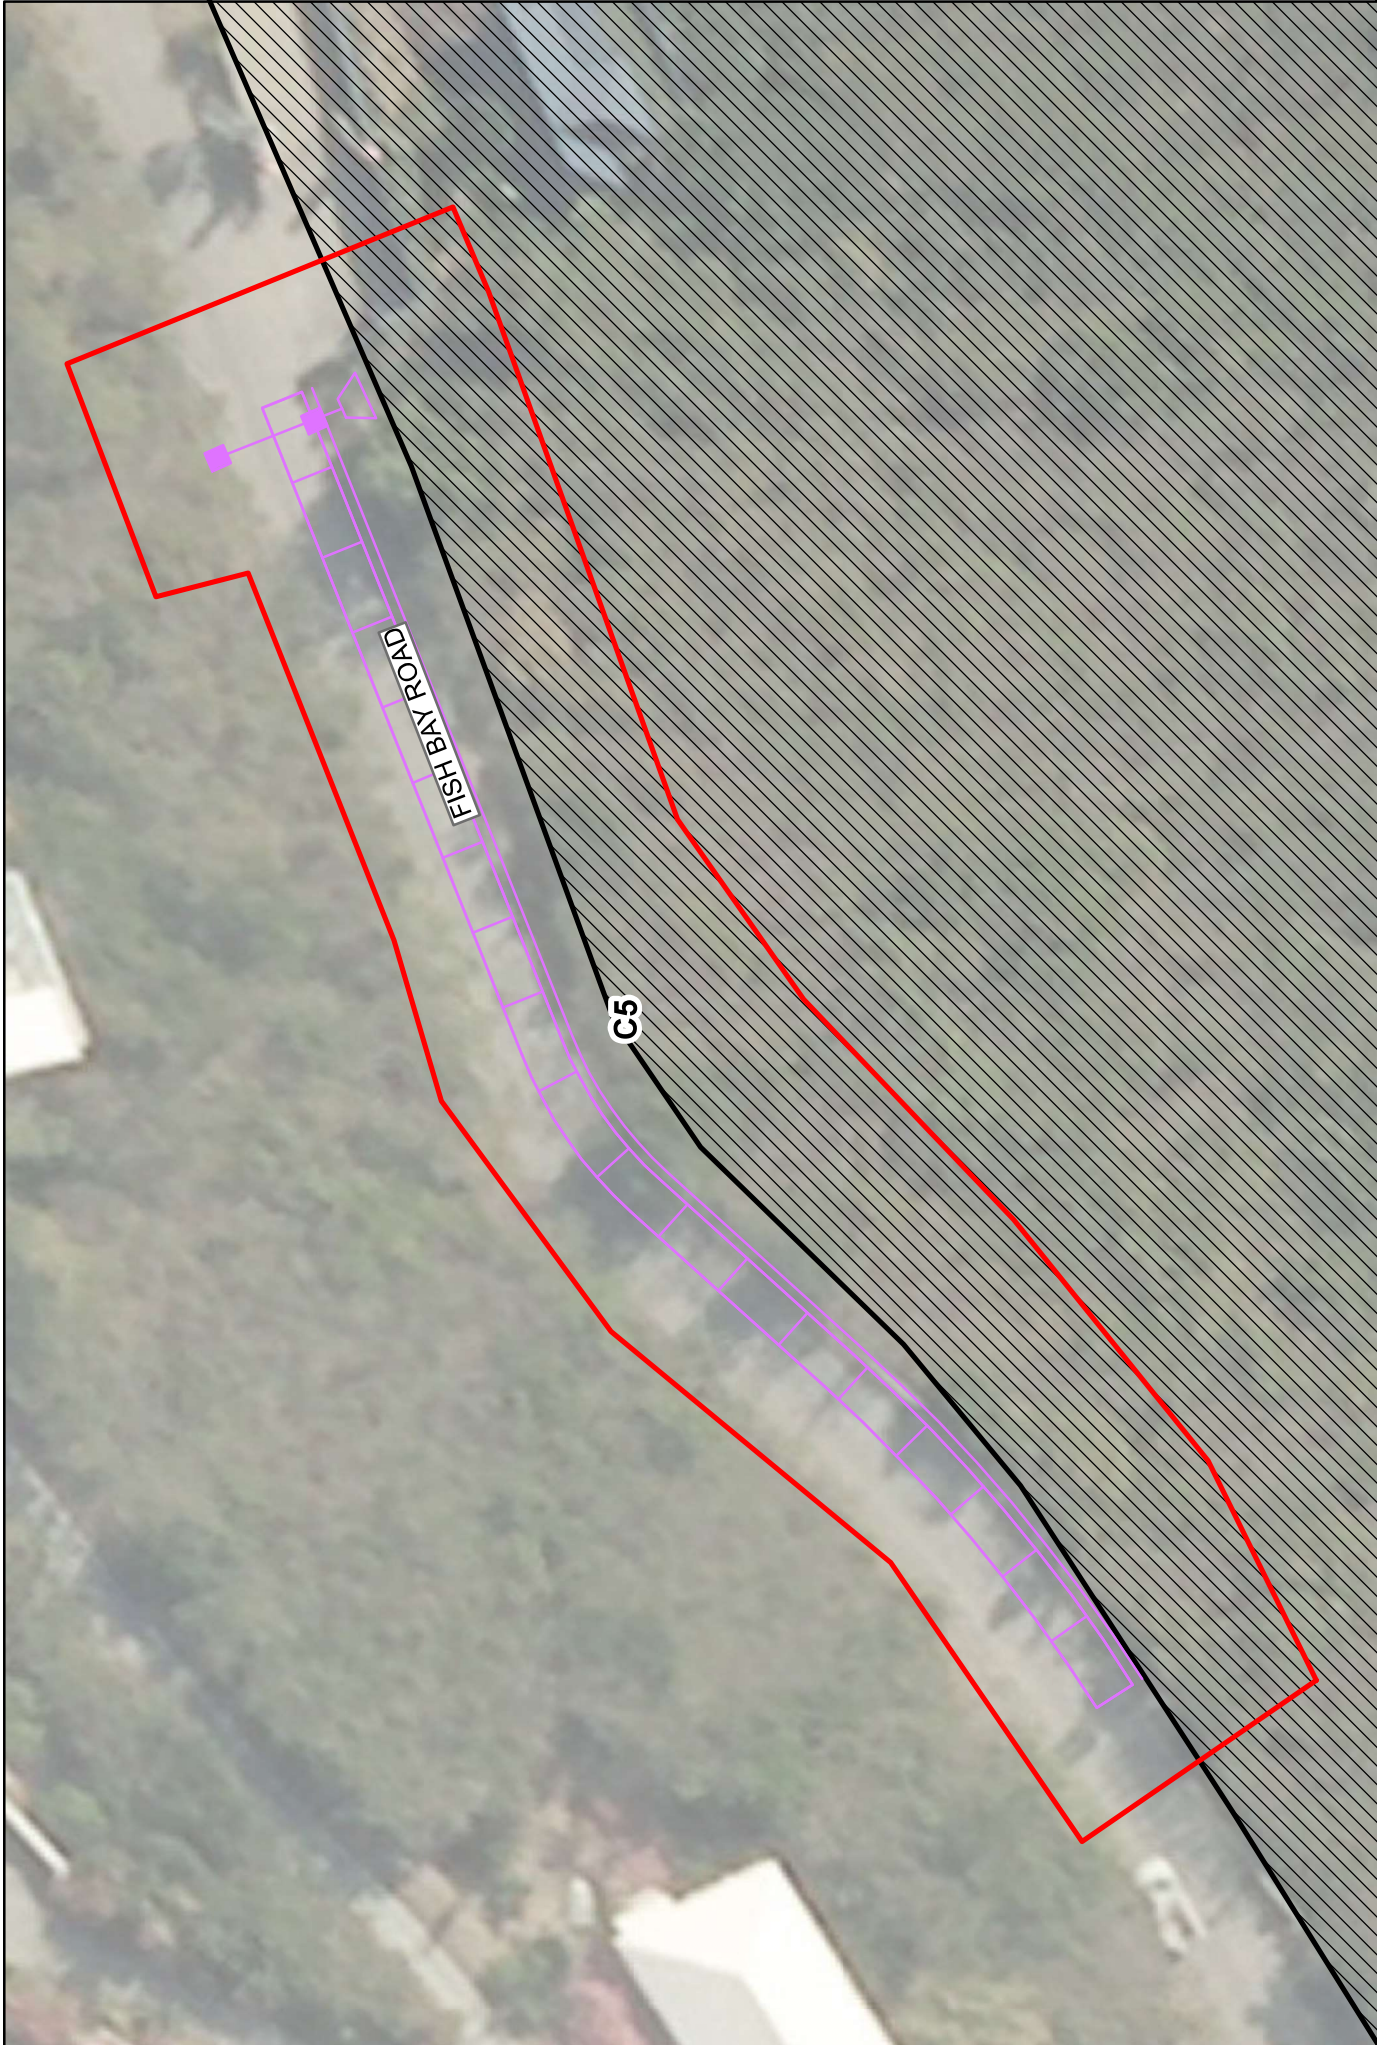
FIGURE 4: SITE C5  
ST JOHN: US VIRGIN ISLANDS  
ROADWAY REPAIRS

Site C5 (Figure 4) was impacted by slope failure, erosion, and undercutting of the concrete road. A detailed damage description is included in Appendix B and detailed conceptual design plans can be found in Appendix C. Proposed work includes temporary shoring and bracing; removal of one lane of existing concrete road; construction of a new cantilevered retaining wall; removal and replacement of the catch basin and culvert; installation of a drop manhole at the retaining wall; installation of mortared riprap/boulders/gabions at the outfall; and installation of guardrail.
